Laser Spot Thermography – Scanning Mode

ABSTRACT

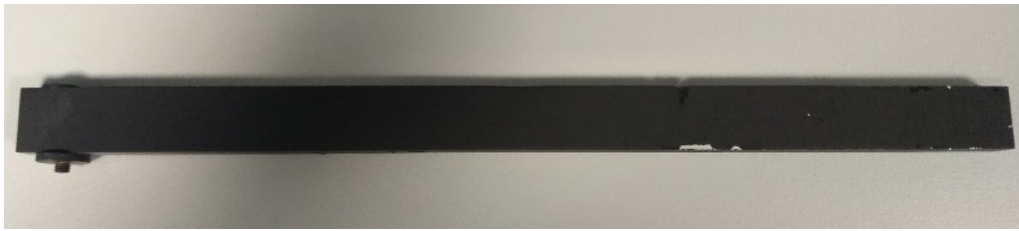
Figure 1. Tested sample – photo, schematic and microscopic view.

An aluminium bar was selected, as an experimental specimen. The overall dimensions of the bar were 300x20x10mm. At first an artificial defect (a small notch) was introduced into the bar structure, using a wire-cut electric discharge machining (EDM). Then the sample was subjected to a fatigue test. The test was ended, when the crack reached the depth of approximately 10mm. At the final preparatory step, the sample was also painted black in order to improve (increase) its thermal emissivity. Figure 1 shows the photo and schematic of the tested sample and microscopic image of the introduced crack area.

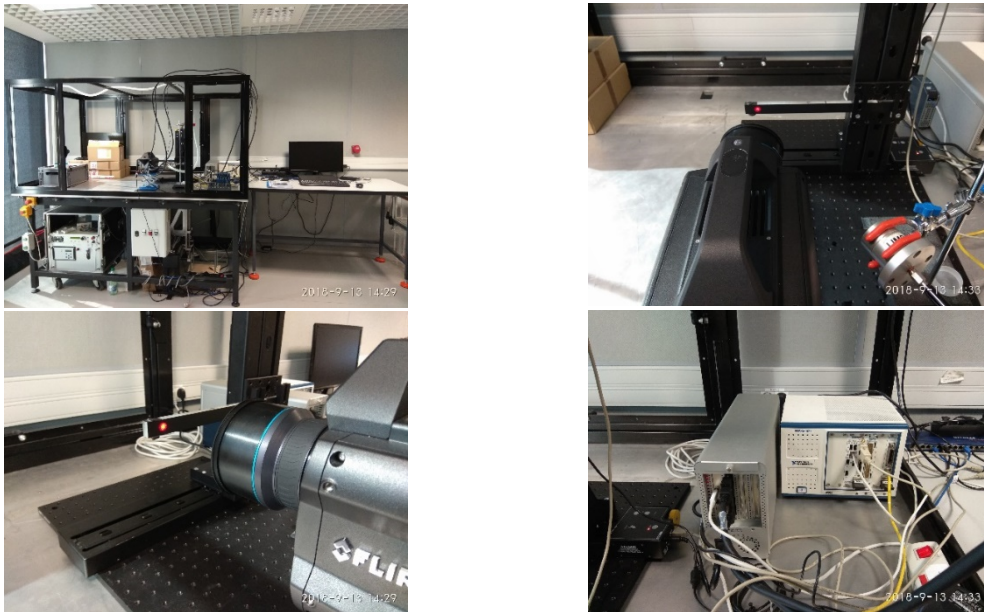
Figure 3. Laser thermography – test rig (photos)

Figure 4. Laser spot thermography measurement procedure

Figure 3 shows real photos of the laser spot thermography test rig. In this arrangement, position of both IR camera and laser beam source were fixed. Sample scanning was performed by two axis stepper motors. There are, also other known configurations of laser spot thermography, where laser head and/or IR camera are mounted to robotic manipulator. Such arrangement is usually used for bigger structures, which could be more cumbersome to manipulate.

This article shows the results from laser spot thermography, where scanning was performed in a point by point manner. Figure 4 shows the laser spot measurement procedure. In this procedure short (100ms) laser pulse was delivered to the structure, at each measurement point. The IR camera synchronized with the laser controller captures the thermal signature prior, during and after the laser excitation event. The whole experiment consists of 13 single excitations, each at a different position of the laser beam.

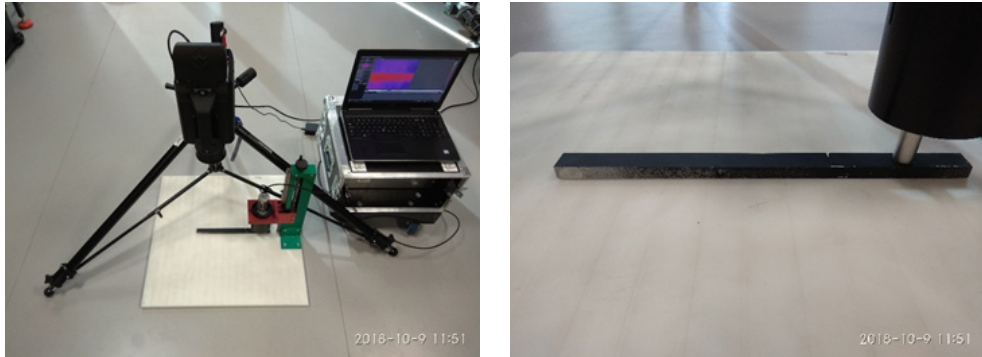
Figure 9. Vibrothermography setup – real photo

One of products of friction is heat, which transfers in all directions around its origin. If heat reaches a surface of a tested object, it can be detected by a IR camera. Figures 8 and 9 show vibrothermography test system, which consists of: vibration source, IR camera, control unit and a PC computer for data acquisition.
